Circular 132-AN/93

### AIRCRAFT ACCIDENT DIGEST No. 21

Japan Air Lines, DC-8-62, JA-8040, accident at Moskva/Sheremetievo, USSR, on 28 November 1972. Report not dated, released by the Deputy Minister of Civil Aviation of the USSR

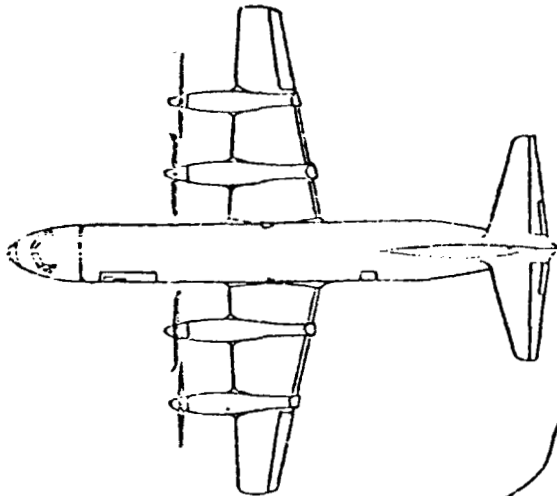
The main gear penetrates the ice, the outboard propellers begin to slash the ice and the nose gear truss girders and shock tube tear out with the fuselage rupturing at FS 200.

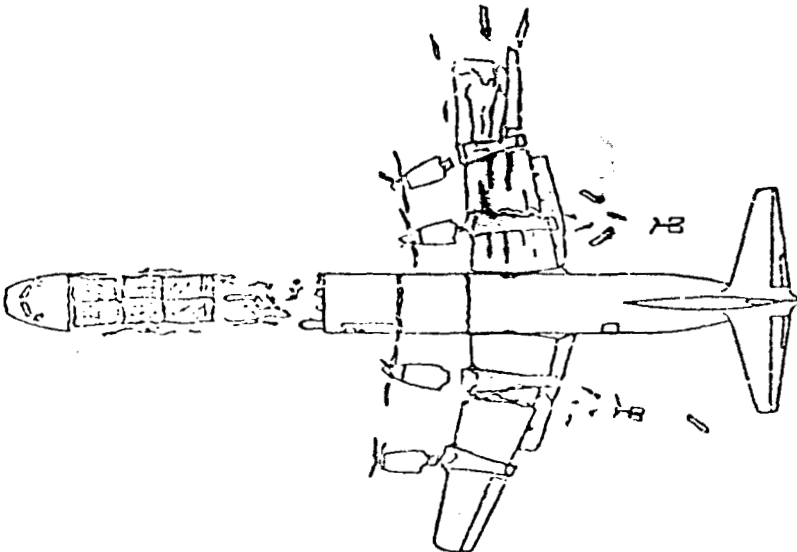
The nacelles and wing centre box contact the ice, the propellers, gearbox and engines separate from the wings, the fuselage ruptured at FS 570, the right wing exploded outboard of WS 170, the left wing separated intact outboard of WS 170 and the centre wing box disintegrated. The cockpit and bulk cargo slid ahead of the decelerating structure, and the passengers, seats and emergency gear cabinet broke free within the aft fuselage.
